ABS removal from a 2003 R1150 GS with servo brakes

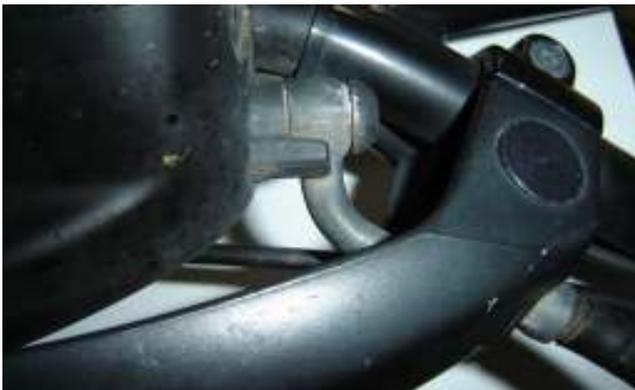
Above is front master cylinder banjo connection. At right is the 'T' piece to split hoses to each of the front calipers. We chucked all the brake lines and fitted a new braided set from HEL Performance that are all one piece. About \$320AUD incl tax.

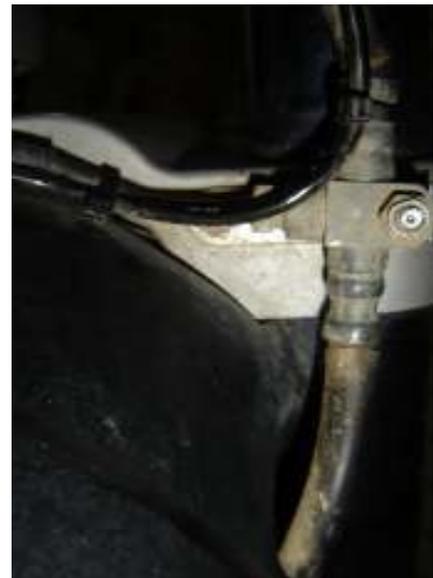
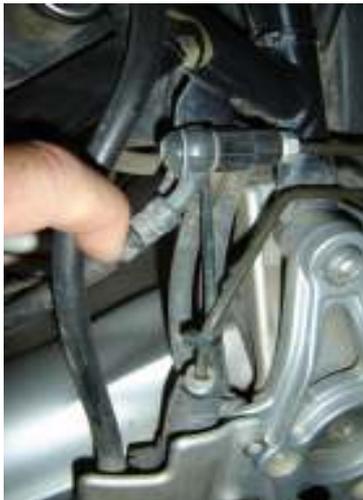
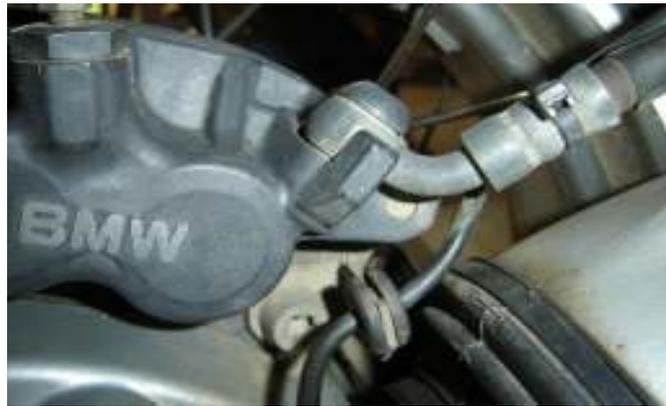
Above left shows the existing rear hose. It can be transferred direct to the master cylinder where the steel line is connected. Above is the rear caliper banjo. Below left is one of the front caliper banjos. Below is brake line connection under the tank on the right side of the steering head. If you aren't fitting new one piece lines you need to replace this with a non ABS fitting.

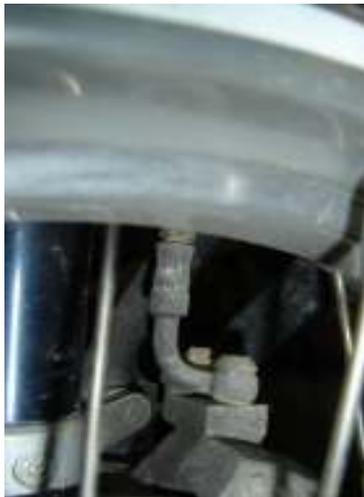
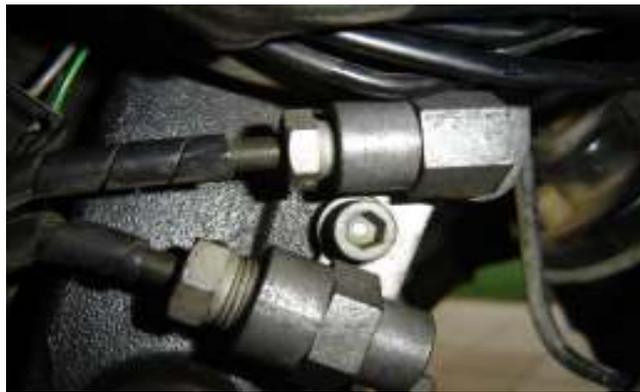
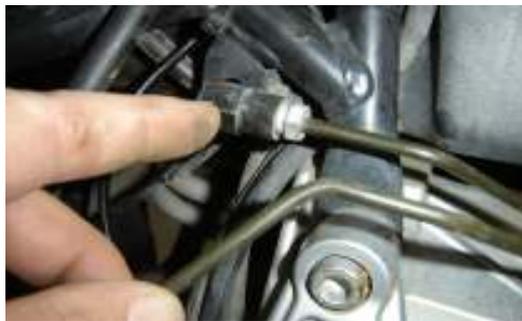
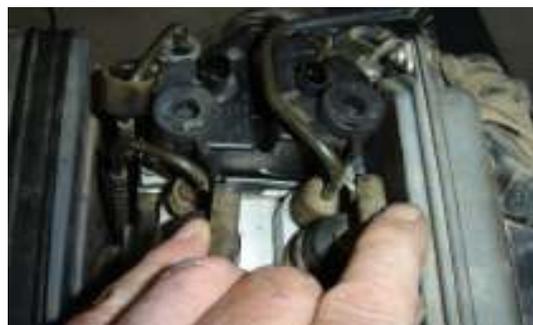
Above left is the original rear brake hose connection from the ABS. This is redundant and can be removed. There is an M6 screw behind the frame tube. Pointing at the rubber caps on the brake lines on the servo unit. There are four of these. Slide them back up the lines. They've gotta go.

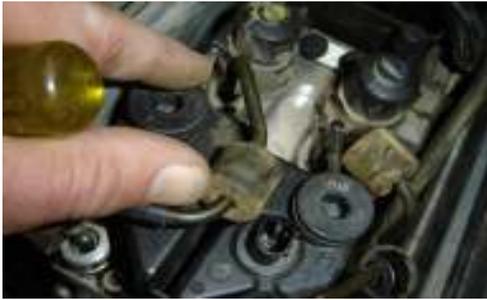
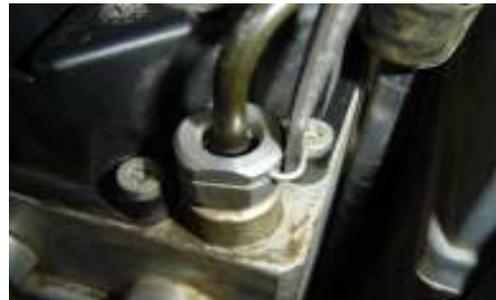
Above left. - Caps pulled back.
Above right. - Lever out the spring clips. (Note the previously bent screw driver from a previous over exertion. An unintentional handy modification).

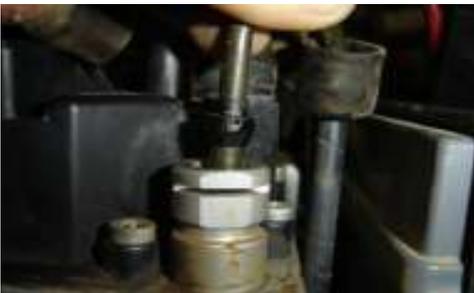
Left - Now you can pull the lines out. I should have mentioned earlier. Pack lots of rags around stuff when pulling out the brake lines. Brake fluid goes everywhere and isn't as good as polish at keeping your bike looking new. Actually, it eats paint. Be careful!

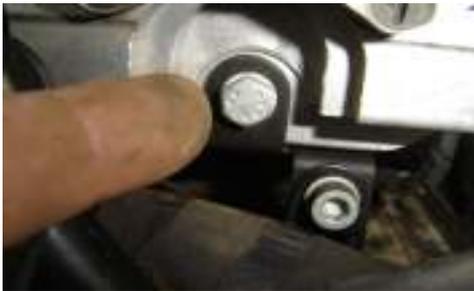
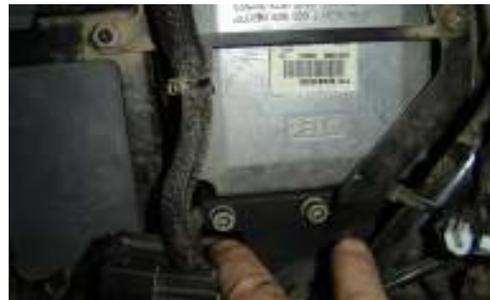
Remove the three screws I'm pointing at. Remember the digits? The ABS servo can now be lifted out. Chuck it on the floor with all the other leftovers. See below. Congratulations your bike is now about 4Kg lighter.

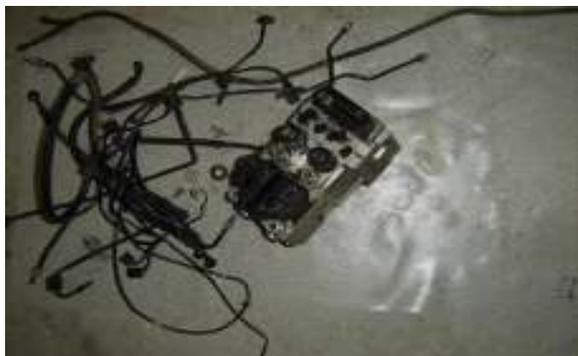
Non ABS brake switches are required. They are Normally Closed. ABS ones are normally open. The part numbers we bought were. Front 61312305729 and Rear 61311459747. These had the wrong plugs on them so maybe they are off another model or maybe the non ABS has a different harness. No big deal anyway as the plug ends were just cut off and the old ones soldered back on the new switch wires. Heat shrink 'em and it should all work a treat.

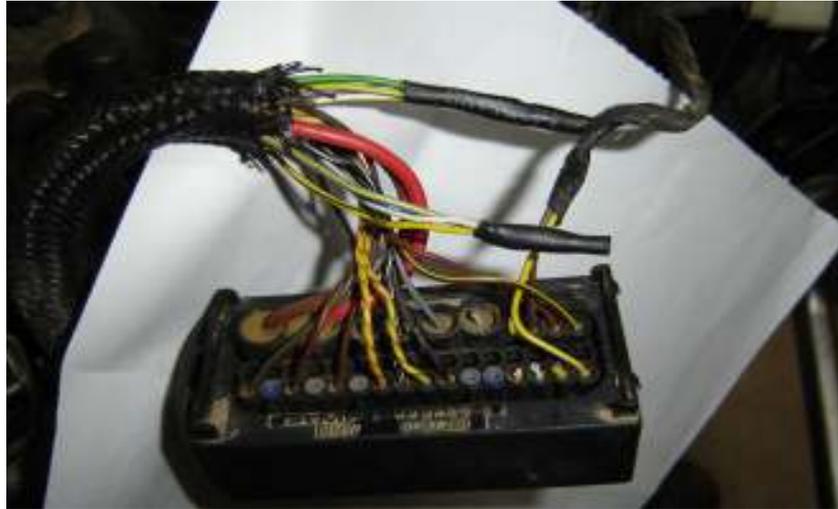
This shows the servo unit plug with the wires snipped off and rejoined as per the rewiring diagram. They were soldered and triple heat shrink wrapped.

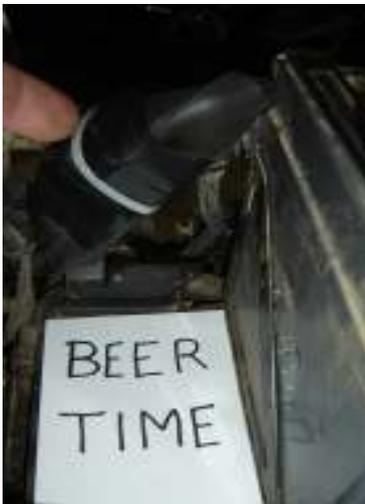
Plug then had the top clipped back on and the whole lot wrapped in a piece of old inner tube then cable tied to support it.
